## **POST-MINING REHABILITATION, LAND USE AND POLLUTION**

### **AT COLLIERIES IN SOUTH AFRICA**

D. Limpitlaw<sup>1</sup>, M. Aken<sup>2</sup>, H. Lodewijks<sup>2</sup> and J. Viljoen<sup>3</sup>

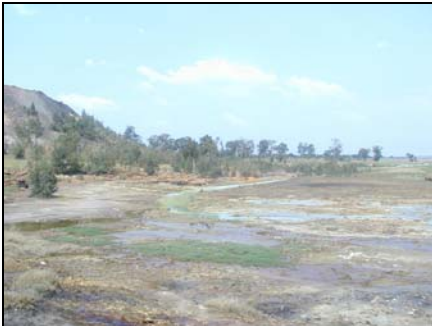
**Figure 1.** Water pollution arising from T&DB, an abandoned coal mine near Witbank.

At the old, abandoned Transvaal and Delagoa Bay colliery (T&DB), in Witbank, sink holes associated with *in situ* combustion of coal are evident. Bare patches are present around the sinkholes and gases are vented to atmosphere. The operation closed before rigorous closure practice was common and the former owners are no longer traceable. Rehabilitation of the site, now the responsibility of the state, may cost up to R100-million (Witcomb, pers. comm., 2001). The colliery began operating towards the end of the 19th century. Fires soon started, but were controlled while the mine was operating. Since closure in 1953, the fires have been out of control and in 1995, flames could be seen above ground. The 750 ha colliery site lies between the township of KwaGuqa and the industrial area of Ferrobank. Footpaths crisscross it, passing close to burning areas. Underground fires are not the only problem at the site. Acid water decants into the nearby Brugspruit. A R30-million treatment plant has been established treat this water but there are doubts about its effectiveness.

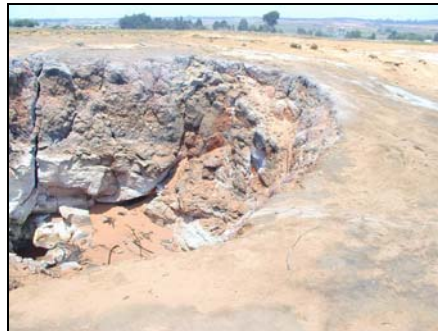
**Figure 2.** Surface collapse due to abandoned burning workings at T&DB.
